Report Index

4722 Baltimore Avenue (Unit 3 - 3rd Floor Apartment)
Philadelphia, PA 19143.

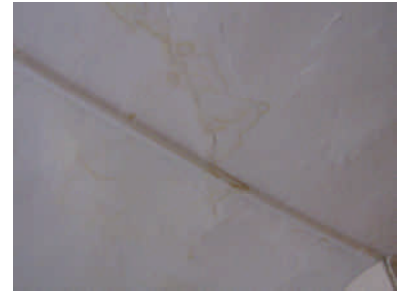
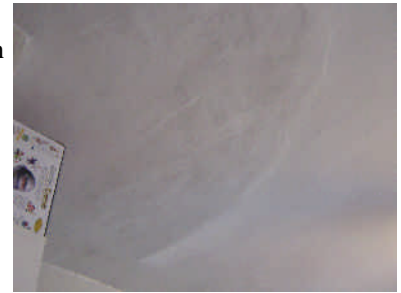
Appears Serviceable, Minor to moderate cracks were noted on the ceiling due to normal settling, Minor to moderate stains were noted on some ceilings, Excess moisture content (more than 20%) was noted at the stains (32% at the stains)

Recommendations: Active moisture problems were noted in this area during the inspection (Air sampling is recommended) (\$120 for each interior sample in addition to the exterior baseline sample)

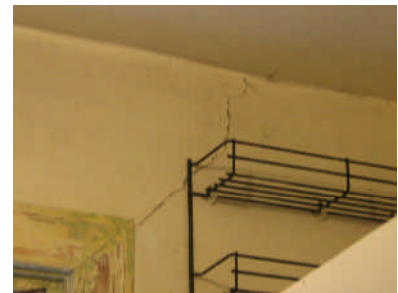
Appear Serviceable, Minor cracks were noted on some walls and ceilings due to normal settling.

Suggestions: Suggest repairing the damaged wall / ceiling areas to prevent further damage (\$1.50 to \$2.50 per square foot) (**Normal Maintenance**)

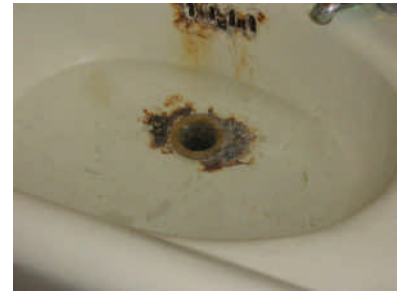
Appear Serviceable, Drain stopper did not operate, Minor to moderate wear was noted on the sink.

Suggestions: Suggest replacing the drain stopper for use (\$75 to \$150) (**Normal Maintenance**), Suggest applying a porcelain patch kit to prevent further damage (\$25 to \$50) (**Normal Maintenance**)

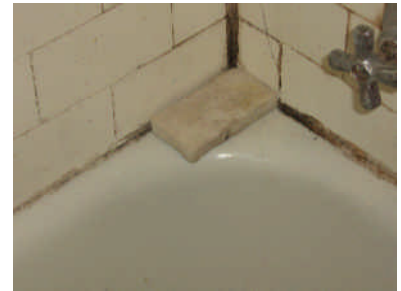
Appear Serviceable, Minor cracks were noted on the mortar between some tiles.

Recommendations: Recommend having the cracks in the mortar patched to prevent water from entering the bathroom walls (\$3+ per square foot) (**Normal Maintenance**)

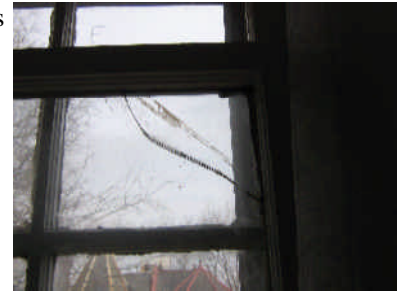
Appears Serviceable, Some windows are cracked (Master Bedroom), Some windows are difficult to operate, Minor to moderate weathering was noted on some window frames, Weather stripping is missing, insufficient, and/or air drafts were noted around the windows.

Suggestions: Suggest replacing the the glass to prevent further cracking (\$35 to \$45 per square foot) (**Maintenance with Repair**) (Master Bedroom), Suggest having the windows adjusted and/or replaced for use (\$30 to \$60) (**Normal Maintenance**), Suggest sanding, sealing, and painting the window frames to protect the exposed wood from the weather (\$2 to \$3 per square foot) (**Normal Maintenance**), Suggest installing additional weather stripping to prevent air drafts from entering the structure (\$25 to \$50) (**Normal Maintenance**)
