# Report Index

**INSPECTION ADDRESS:**

4722 Baltimore Avenue (Unit 2 - 2nd Floor Apartment)  
Philadelphia, PA 19143.

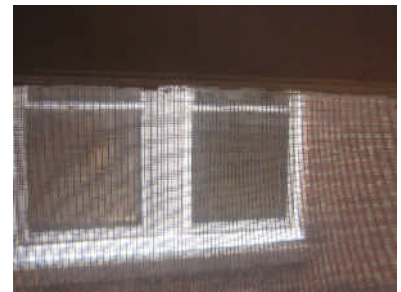
Appears Serviceable, Some windows are cracked, Some windows are difficult to operate, Minor to moderate weathering was noted on some window frames, Weather stripping is missing, insufficient, and/or air drafts were noted around the windows.

**Suggestions:** Suggest replacing the glass for prevent further cracking (\$35 to \$45 per square foot) (**Maintenance with Repair**), Suggest having the windows adjusted and/or replaced for use (\$30 to \$60) (**Normal Maintenance**), Suggest sanding, sealing, and painting the window frames to protect the exposed wood from the weather (\$2 to \$3 per square foot) (**Normal Maintenance**), Suggest installing additional weather stripping to prevent air drafts from entering the structure (\$25 to \$50) (**Normal Maintenance**)

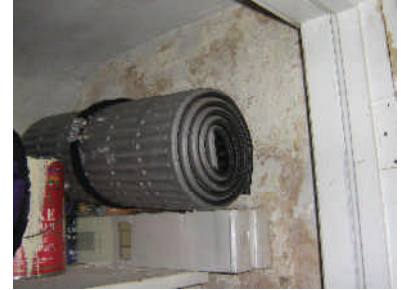
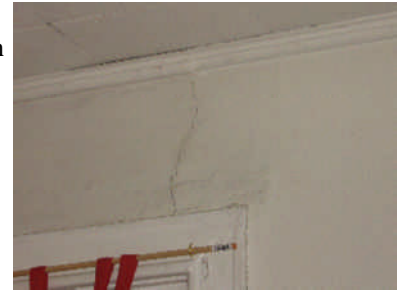
Appears Serviceable, Minor to moderate cracks were noted on some walls due to normal settling, Minor to moderate water damage was noted on some walls, Excess moisture content (more than 20%) was noted at the damage (75% on the right wall)

**Recommendations:** Active moisture problems were noted in this area during the inspection (Air sampling is recommended) (\$120 for each interior sample in addition to the exterior baseline sample),

**Suggestions:** Suggest repairing the damaged areas to prevent further damage (\$1.50 to \$2.50 per square foot) (**Normal Maintenance**)

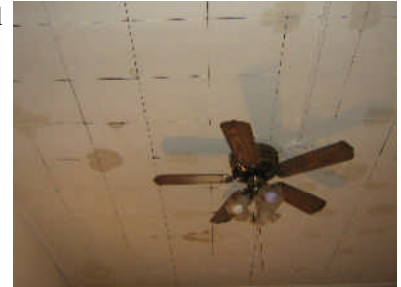
Appears Serviceable, Minor to moderate stains were noted on some ceilings, Normal moisture content (less than 18%) was noted at the stains.

**Suggestions:** Suggest replacing the damaged and/or missing ceiling tiles (aesthetic value only) (\$3 to \$5 per square foot) (**Normal Maintenance**)

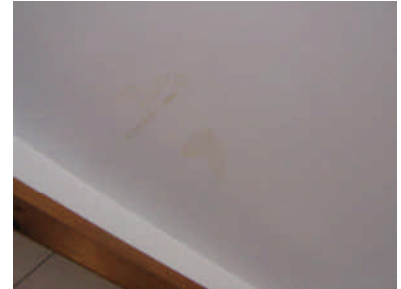
Appear Serviceable, Minor to moderate stains were noted on some ceilings, Normal moisture content (less than 18%) was noted at the stains.

**Suggestions:** Suggest having the windows adjusted and/or replaced for use (\$30 to \$60) (**Normal Maintenance**), Suggest sanding, sealing, and painting the window frames to protect the exposed wood from the weather (\$2 to \$3 per square foot) (**Normal Maintenance**), Suggest installing additional weather stripping to prevent air drafts from entering the structure (\$25 to \$50) (**Normal Maintenance**), Suggest replacing the damaged cabinets for use (\$250+ per linear foot) (**Maintenance with Repair**)

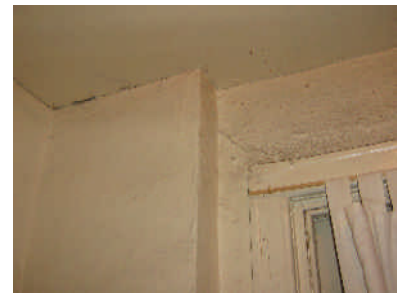
Appear Serviceable, Minor cracks were noted on some walls due to normal settling, Installed paneling on the ceiling is loose.

**Suggestions:** Suggest patching the cracks to prevent further damage (\$1.50 to \$2.50 per square foot) (**Normal Maintenance**), Suggest having the paneling secured and/or removed (aesthetic value only) (\$2+ per square foot) (**Normal Maintenance**)

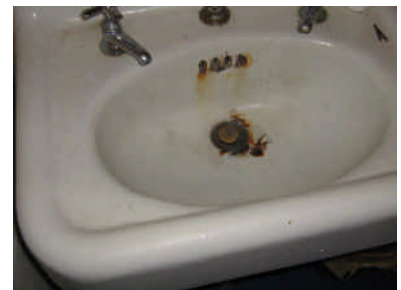
Drain stopper did not operate, Moderate to heavy wear was noted on the sink.

**Suggestions:** Suggest replacing the drain stopper for use (\$75 to \$150) (**Normal Maintenance**), Suggest applying a porcelain patch kit to prevent further damage (\$25 to \$50) (**Normal Maintenance**)

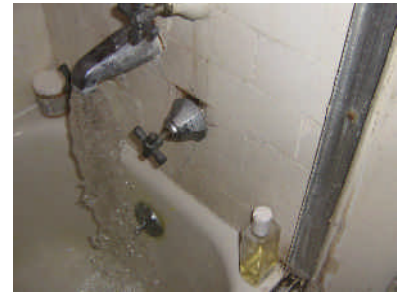
Appear Serviceable, Minor cracks were noted on the mortar between some tiles.

**Recommendations:** Recommend having the cracks in the mortar patched to prevent water from entering the bathroom walls (\$3+ per square foot) (**Normal Maintenance**)

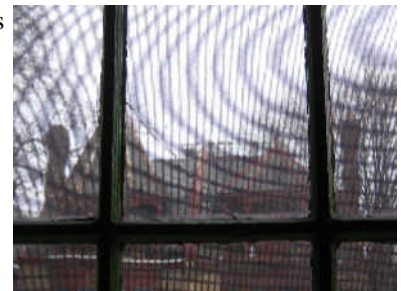
Appears Serviceable, Some windows are cracked (Master Bedroom), Some windows are difficult to operate, Minor to moderate weathering was noted on some window frames, Weather stripping is missing, insufficient, and/or air drafts were noted around the windows.

**Suggestions:** Suggest replacing the the glass to prevent further cracking (\$35 to \$45 per square foot) (**Maintenance with Repair**), Suggest having the windows adjusted and/or replaced for use (\$30 to \$60) (**Normal Maintenance**), Suggest sanding, sealing, and painting the window frames to protect the exposed wood from the weather (\$2 to \$3 per square foot) (**Normal Maintenance**), Suggest installing additional weather stripping to prevent air drafts from entering the structure (\$25 to \$50) (**Normal Maintenance**)

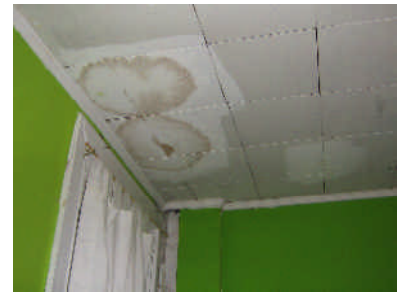
Appears Serviceable, Minor to moderate stains were noted on some ceilings (Bedroom 2), Normal moisture content (less than 18%) was noted at the stains.

**Suggestions:** Suggest replacing the damaged and/or missing ceiling tiles (aesthetic value only) (\$3 to \$5 per square foot) (**Normal Maintenance**) (Bedroom 2)

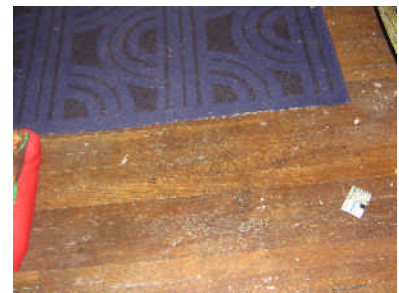
Appears Serviceable, Minor to moderate deterioration was noted on the flooring.

**Suggestions:** Suggest having the floor coverings repaired and/or replaced (aesthetic value only) (Carpet: \$25 to \$50 per square yard; Tile: \$15+ per square foot; Vinyl: \$3+ per square foot; Wood: \$6 to \$12 per square foot) (**Normal Maintenance**)
