Report Index

4722 Baltimore Avenue (Unit 3 - 3rd Floor Apartment)
Philadelphia, PA 19143.

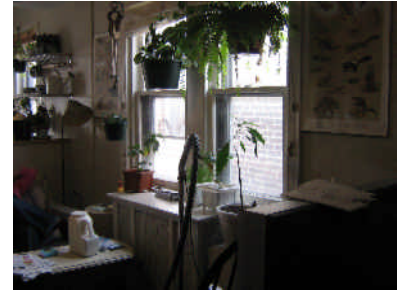
LIVING ROOM:
3rd Floor, Center.

Appears Serviceable, Some windows are difficult to operate, Minor to moderate weathering was noted on some window frames, Weather stripping is missing, insufficient, and/or air drafts were noted around the windows.

Appears Serviceable, Minor to moderate cracks were noted on the ceiling due to normal settling, Minor to moderate stains were noted on some ceilings, Excess moisture content (more than 20%) was noted at the stains (32% at the stains)

Appears Serviceable, Minor to moderate deterioration was noted on the flooring, Minor to moderate floor squeaks were noted on the wooden floors.

Suggestions: Suggest having the windows adjusted and/or replaced for use (\$30 to \$60) (**Normal Maintenance**), Suggest sanding, sealing, and painting the window frames to protect the exposed wood from the weather (\$2 to \$3 per square foot) (**Normal Maintenance**) Suggest installing additional weather stripping to prevent air drafts from entering the structure (\$25 to \$50) (**Normal Maintenance**)

Recommendations: Active moisture problems were noted in this area during the inspection (Air sampling is recommended) (\$120 for each interior sample in addition to the exterior baseline sample)

Suggestions: Suggest having the flooring repaired and/or re-surfaced (aesthetic value only) (\$1.50 to \$3 per square foot) (**Maintenance with Repair**), Suggest having the wood flooring fully secured to the sub-flooring (\$1.50 to \$3 per square foot), Suggest working talcum powder between the wood flooring to lubricate the nails (temporary measure) (\$5 to \$10 per floor) (**Normal Maintenance**)

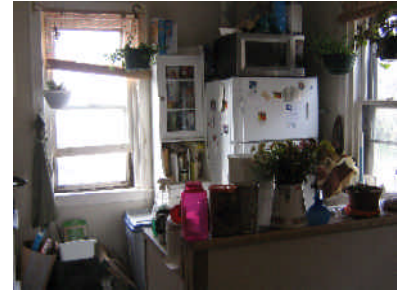
3rd Floor, Rear.

Appear Serviceable, Some windows are difficult to operate, Minor to moderate weathering was noted on the exterior window frames, Bottom window sash does not stay up when the window is opened, Weathering stripping is missing, insufficient, and/or air drafts were noted around the windows.

Appear Serviceable, Several cabinet door hinges are missing and/or loose.

Recommendations: Recommend having the window repaired to prevent damage to the window and to prevent personal injury (\$30 to \$45 per square foot) (**Maintenance with Repair**),
