# Report Index

**INSPECTION ADDRESS:**

4722 Baltimore Avenue (Unit 2 - 2nd Floor Apartment)  
Philadelphia, PA 19143.

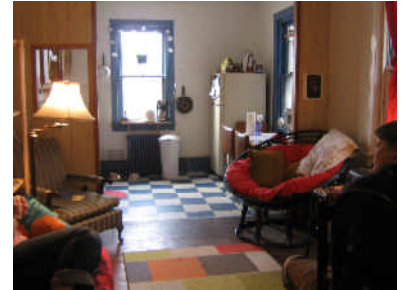
**LIVING ROOM:**  
2nd Floor, Center.

**INTERIOR DOORS:**  
Interior door is missing.

Appears Serviceable, Some windows are cracked, Some windows are difficult to operate, Minor to moderate weathering was noted on some window frames, Weather stripping is missing, insufficient, and/or air drafts were noted around the windows.

Appears Serviceable, Minor to moderate cracks were noted on some walls due to normal settling, Minor to moderate water damage was noted on some walls, Excess moisture content (more than 20%) was noted at the damage (75% on the right wall)

Appears Serviceable, Minor to moderate stains were noted on some ceilings, Normal moisture content (less than 18%) was noted at the stains.

Appears Serviceable, Minor to moderate deterioration was noted on the flooring, Minor to moderate floor squeaks were noted on the wooden floors.

**Suggestions:** Suggest installing a door for use (\$150 to \$250) (**Maintenance with Repair**)

**Suggestions:** Suggest replacing the glass for prevent further cracking (\$35 to \$45 per square foot) (**Maintenance with Repair**), Suggest having the windows adjusted and/or replaced for use (\$30 to \$60) (**Normal Maintenance**), Suggest sanding, sealing, and painting the window frames to protect the exposed wood from the weather (\$2 to \$3 per square foot) (**Normal Maintenance**), Suggest installing additional weather stripping to prevent air drafts from entering the structure (\$25 to \$50) (**Normal Maintenance**)

**Recommendations:** Active moisture problems were noted in this area during the inspection (Air sampling is recommended) (\$120 for each interior sample in addition to the exterior baseline sample),

**Suggestions:** Suggest repairing the damaged areas to prevent further damage (\$1.50 to \$2.50 per square foot) (**Normal Maintenance**)

**Suggestions:** Suggest replacing the damaged and/or missing ceiling tiles (aesthetic value only) (\$3 to \$5 per square foot) (**Normal Maintenance**)

**Suggestions:** Suggest having the wood flooring fully secured to the sub-flooring (\$1.50 to \$3 per square foot), Suggest working talcum powder between the wood flooring to lubricate the nails (temporary measure) (\$5 to \$10 per floor) (**Normal Maintenance**), Suggest having the flooring repaired and/or re-surfaced (aesthetic value only) (\$1.50 to \$3 per square foot) (**Maintenance with Repair**)

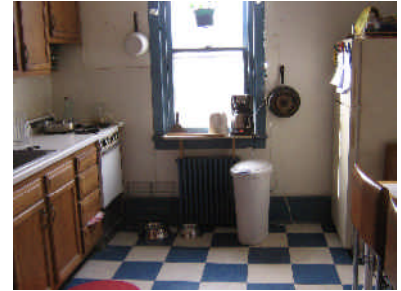
2nd Floor, Rear.

Appear Serviceable, Minor to moderate weathering was noted on some window frames, Weather stripping is missing, insufficient, and/or air drafts were noted around the windows.

Appear Serviceable, Minor to moderate stains were noted on some ceilings, Normal moisture content (less than 18%) was noted at the stains.
